**MEMORANDUM OF AGREEMENT  
SUBMITTED TO THE ADVISORY COUNCIL ON HISTORIC PRESERVATION  
REGARDING  
UPPER OHIO NAVIGATION STUDY, PENNSYLVANIA**

**WHEREAS**, the U.S. Army Corps of Engineers, Pittsburgh District (Corps), through the Upper Ohio Navigation Study, Pennsylvania, is recommending a modernization plan for replacement of lock chambers at Emsworth, Dashields, and Montgomery Locks and Dams in Allegheny and Beaver counties, Pennsylvania; and

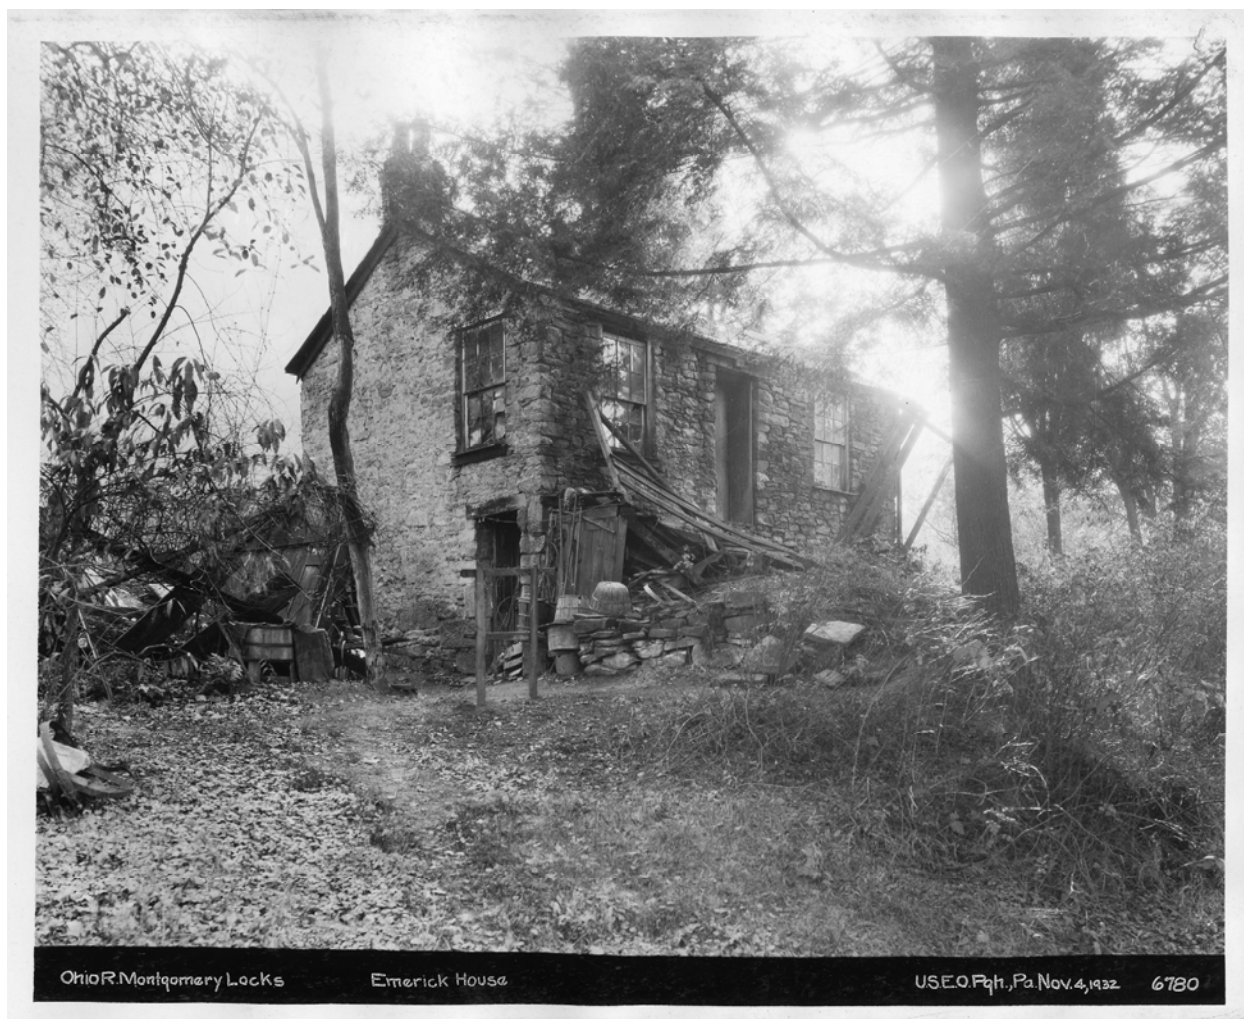
***Photograph 4. Close-Up of Emerick House on November 4, 1932. View to Southwest.  
(Photograph Courtesy of USACE, Pittsburgh District.)***

The former Kenyon-Emerick house was constructed of stone (see Photograph 4). A concentration of rock, some of which appeared to be cut stone, and partial remains of a foundation identified the former house location (Figure 26). The foundation remnant measured 19 x 26 ft (5.8 x 7.9 m) and was constructed of dry laid tabular stone. In some areas, the foundation consisted of several stacked stone rising about one foot (30 cm) above the ground surface while in other areas, no stacked stone courses were encountered. A few dressed stones were found scattered among the stone rubble. This location and the concentration of rocks is consistent with the former Kenyon-Emerick house (see Photograph 4), which has a dry laid foundation supporting a mortared stone house with a few dressed stones apparent around the doorway on the ground floor at the northeast corner (see Photograph 4). The stone rubble is concentrated around the foundation remnant and it appears that much of the construction stones and other construction debris were removed at some time in the past.

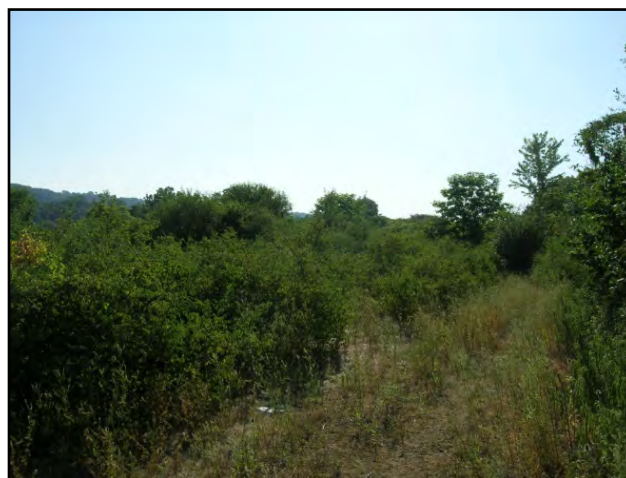
This vacant lot was covered by scrub growth and young mixed hardwoods (Photographs 5 and 6). Monitoring wells dotted this area to monitor for contamination from past industrial activities at this location. A gas line currently runs through this area.

***Photograph 5. Overview of Emsworth, Primary Study Area. View to Northeast.***

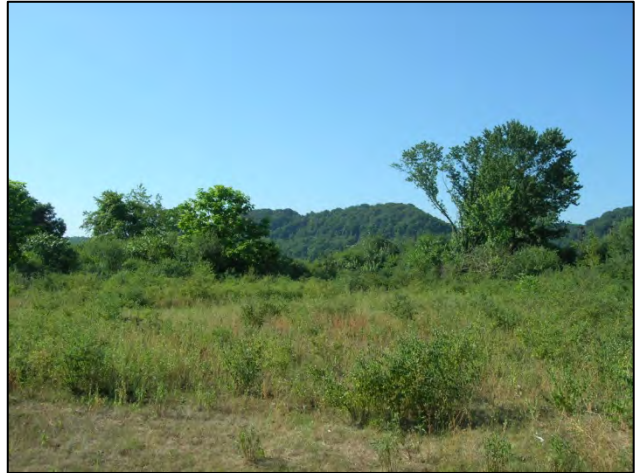
This parcel was heavily disturbed by prior industrial activity. The Soil Survey designates this location as Urban Lands. Urban Lands are characterized by level-to-nearly-level lands on the floodplain covered by over two feet of fill material (Newbury et al. 1981:31).

***Photograph 6. Emsworth Primary Study Area. View to Northeast.***

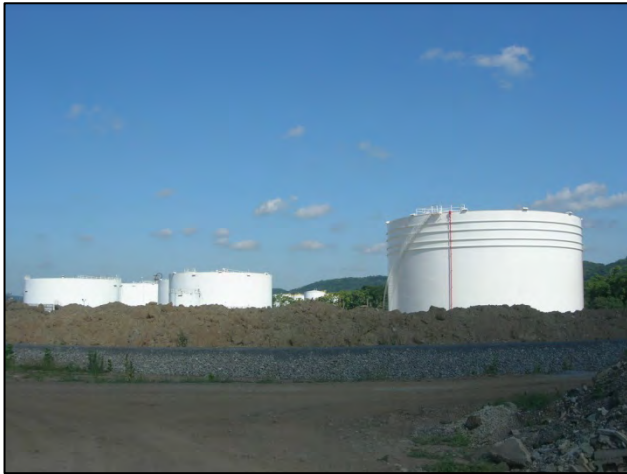
At the time of the pedestrian reconnaissance, 250,000-gallon petroleum storage tanks were built and others were being constructed on the property (Photograph 7). Large-scale earthmoving activities were associated with these storage tank fields. There was a large concrete pad of unknown function that covered a large section of this area (Photograph 8). There were also piles of railroad ties and other railroad-related debris.

***Photograph 7. Storage Tank (on right) in Emsworth Secondary Study Area. View to Northwest.***

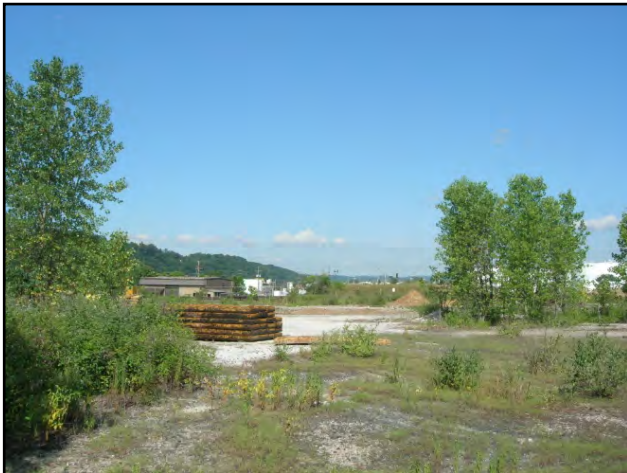
***Photograph 8. Concrete Pad and Storage Pile in Emsworth Secondary Study Area. View to Southwest.***

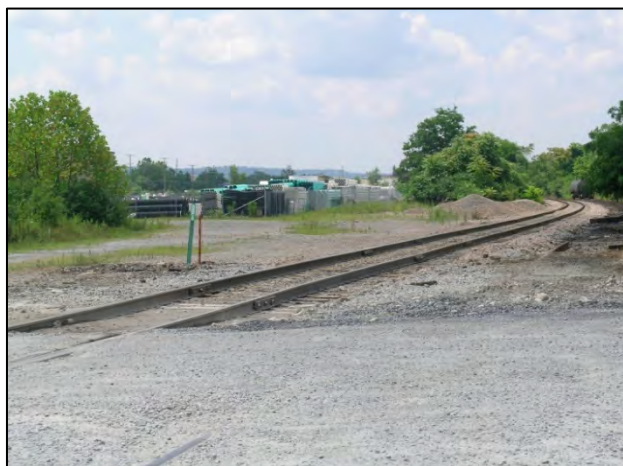
Constructed in 1899, the Pittsburgh & Ohio Valley Railway (P&OV) is a shortline railroad that runs a distance of 2.04 miles on the heavily industrialized Neville Island (Photograph 9). This switching line performs general freight service (Saylor 1964: 255-256). It connects with the Pittsburgh & Lake Erie Railroad (P&LE) and the Pittsburgh, Chartiers & Youghiogeny Railroad (PC&Y) (Harvey 2002: 67). During the early-twentieth century, the P&OV was owned by the U.S. Steel Corporation, after which the Pittsburgh Coke and Chemical Company acquired it. In December 1993, CSX purchased the line (Lewis 1996: 360).

***Photograph 9. Pittsburgh & Ohio Valley Railway. View to the Northeast.***

In the vicinity of the study area, the Pittsburgh & Ohio Valley Railway consists of a single-tracked alignment of steel rails on wood ties constructed on stone ballast. There are several at-grade crossings of this railroad in the study area vicinity; however, there are no other associated railroad structures or facilities (bridges, depots, shops, etc.) within the immediate area.

While this short line railroad is associated with the industries of Southwestern Pennsylvania, it functions as a service railroad, connecting industrial facilities on Neville Island. It is not significant as a primary piece of transportation infrastructure, as other lines in the region provide greater service to outside markets. Therefore, the P&OV is recommended not eligible for NRHP listing under Criterion A. No information could be located that connects this railroad to any individuals significant in the history of the region. As such, this resource is recommended not eligible for NRHP listing under Criterion B. This railroad line stands as a typical single-track alignment, and no ancillary structures of engineering or architectural significance are located within the study area vicinity. Due to this relative lack of design significance, this resource is recommended ineligible for NRHP listing under Criterion C. Since the Pittsburgh & Ohio Valley Railway is recommended ineligible for listing on the NRHP, no further work is required.

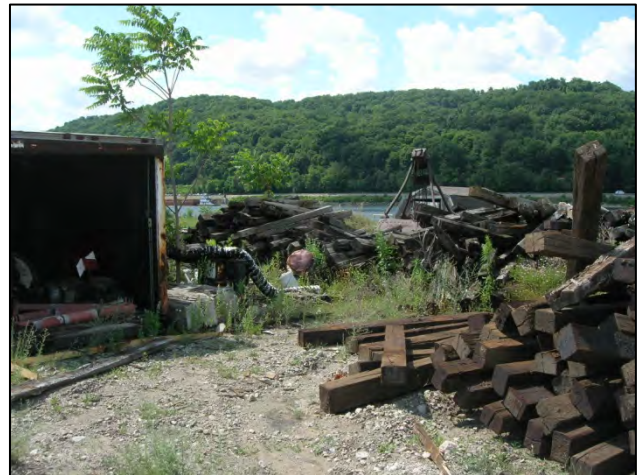
The two smaller parcels comprising Dashields Primary study area fell within an industrial park and were heavily disturbed. Along the Ohio River, the large west parcel was used to offload barges. Large back-dirt piles, refuse, and 55-gallon drums were observed (Photograph 10). Trees and scrub growth covered parts of this parcel. All three land parcels fell within Urban Lands.

***Photograph 10. Refuse Piles in Dashields Primary, West Parcel. View to Southeast.***

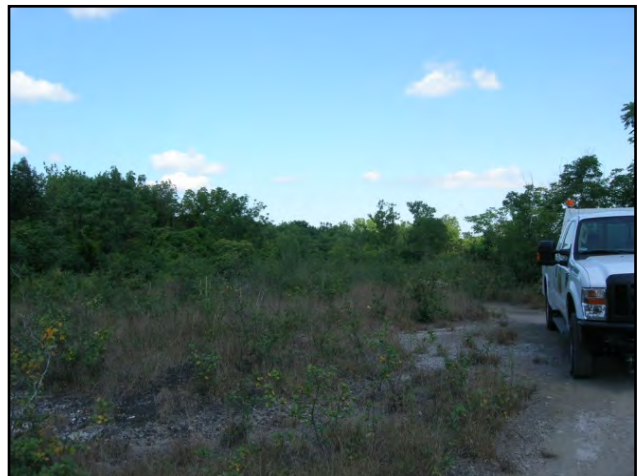
The large parcel east of Sewickley Creek was used as a mulch stockpile area for Edgeworth Borough. Fill deposits, mulch piles, and steel, railroad ties, rocks, and other miscellaneous debris piles were visible. A sewage line (and lift station) is situated on the south side of the railroad right-of-way. There were mixed hardwoods forests along Sewickley Creek, along the railroad tracks, and near the road paralleling the Ohio River. The remaining areas either were cleared of vegetation or had scrub growth (Photograph 11). Some areas were unvegetated because slag was exposed on the ground surface.

***Photograph 11. Overview of Dashields Primary. View to East. (Note: Jeep is located on a slag surface.)***

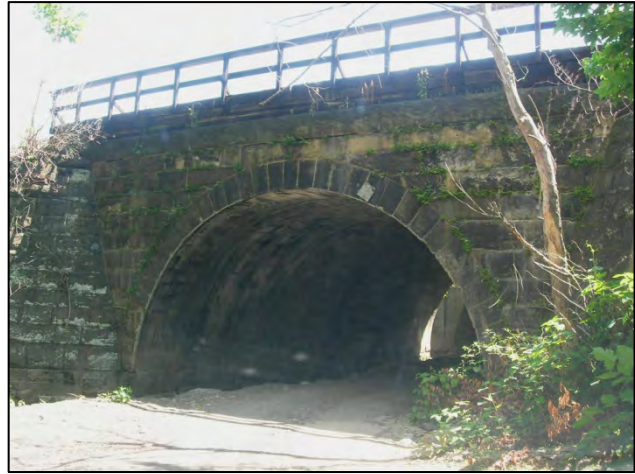
***Photograph 12. Railroad Underpass. View to North.***

There were no resources over 50 years of age identified during the architectural and historical survey of Dashields Primary. A railroad underpass, over 50 years of age, was observed while accessing Dashields Primary via a borough park (Photograph 12). However, this overpass will not be affected by the current undertaking, as access to this study area will be obtained through the industrial park.

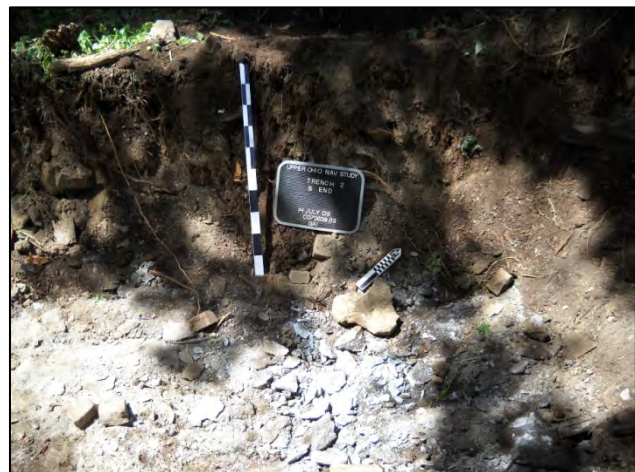
***Photograph 13. Typical Machine-excavated Trench Sample. View to Northwest.***

Excavations documented recent fill over industrial slag, which formed a barrier at least 6 ft thick (Photograph 13). Machine excavation failed to penetrate the slag deposits at any of the six locations (each end of three trench locations) where it was attempted in one day of excavation (Figure 21).

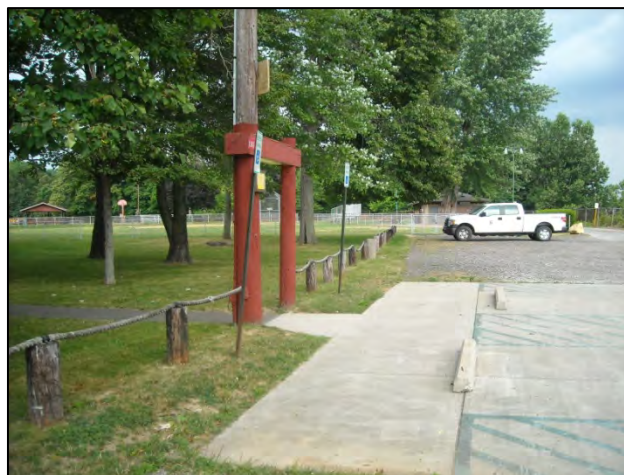
Excavations documented Site 36AL600, a multicomponent site with a prehistoric lithic scatter or open habitation site and a historic artifact scatter found within a buried A horizon in the park area (Photograph 16; see Figure 22). The typical soil profile consisted of a CA horizon (fill) comprised of brown silt loam (10YR5/3) overlying an Ab horizon (buried A horizon) composed of dark brown silt loam (10YR3/3) capping yellow brown clay loam (10YR5/6) sterile subsoil (B horizon) (see Figure 23). Site 36AL600, discovered while digging shovel probes at Dashields Secondary, measured approximately 76x18 meters. Shovel testing at the site consisted of five positive shovel probes at 15-meter intervals. Of the 18 radial shovel probes excavated at 5-meter intervals around the four positive tests, three produced artifacts.

**Photograph 16. Overview of Site 36AL600.  
View to Northwest.**

**Recommendations.** Site 36AL600 is a multicomponent site with a Late Archaic prehistoric component and a historic component found within an intact buried A horizon. This Late Archaic campsite component appears to possess good integrity. The site may have potential to add to our understanding of the prehistory of the region (Criterion D). Additional work would be necessary to assess its eligibility for listing to the National Register of Historic Places.

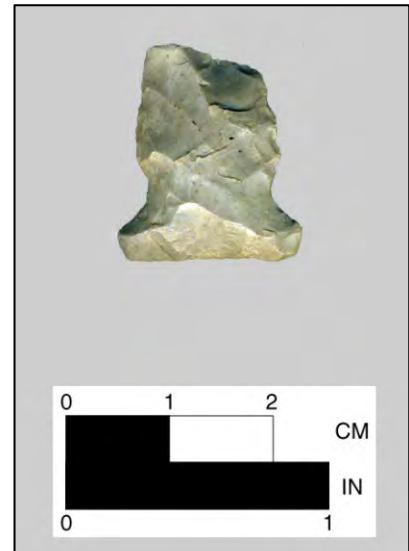
Excavations produced 11 prehistoric artifacts (Table 8) and 18 historic artifacts. Most of the historic artifacts were recovered from the fill deposits except for three whiteware sherds found in the Ab horizon within SP 1. The historic artifacts within the fill deposits (CA horizons) may be from secondary deposition are not considered part of this site. Prehistoric artifacts include one projectile point base, one biface, and nine debitage. The projectile point fragment appears to be a Late Archaic Brewerton side notched point (Photograph 17).

***Photograph 17. Brewerton Side Notched Point Base.***

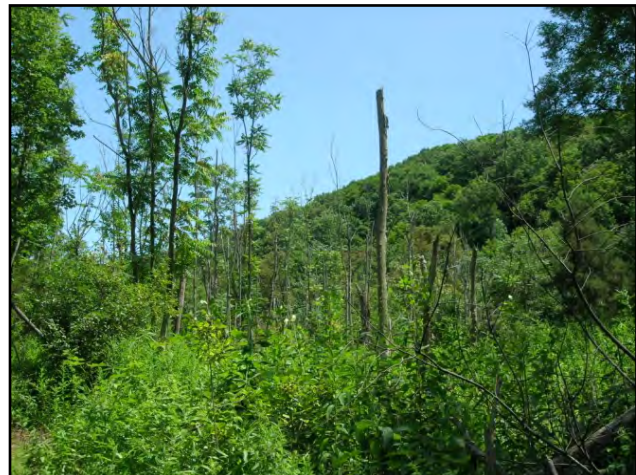
This wooded area had some open areas covered with scrub growth (Photograph 18). The parcels included the floodplain and terraces along the river, and were moderately disturbed by construction of the railroad line, Montgomery locks and dam, and access roads, in addition to flooding and erosion. Erosion and scouring was present along the northern limits of the study area as evidence by water rolled logs caught among the trees in the floodplain west of Squirrel Run.

***Photograph 18. Overview of Montgomery Primary. View to East.***

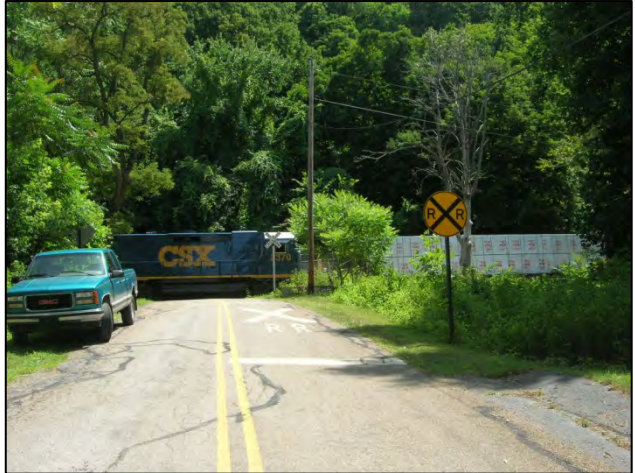
***Photograph 19. Railroad along Montgomery Primary's Southern Boundary. View to South.***

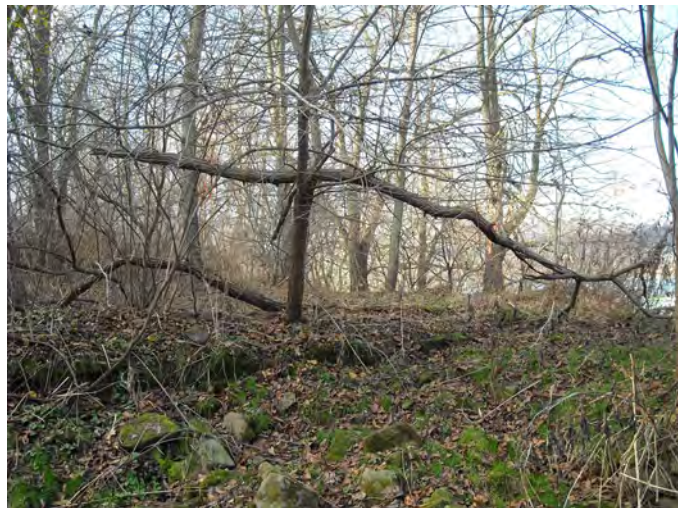
Site 36BV131 was originally reported by a collector as a large prehistoric scatter along the Ohio River. This site was never field checked by a professional archaeologist. SPs were excavated at 15m intervals across a terrace within this previously recorded site (Photograph 21). This study resulted in the identification of both prehistoric and historic artifacts within a much smaller area (152.4x28 m or 500x92 ft) than indicated on the original PASS form.

There were three positive SPs excavated at 15-m intervals along a terrace. Judgmental shovel probes were excavated around a stone house foundation, which appears to be the location of the former Kenyon-Emerick house. Radial shovel testing was conducted around positive SPs around the foundation remains. A surface collection was conducted around a stone house foundation also. Soil stratigraphy consisted of a thin (10-12 cm) very dark grayish-brown (10YR3/2) loam plowzone (Ap horizon) capping a brown (10YR4/3) silt loam AB horizon. All of the artifacts were recovered from the Ap or AB horizon (see Figure 25).

***Photograph 21. Overview of Site 36BV131. View to West.***

**Recommendations.** Site 36BV131 is a previously recorded prehistoric site. The current investigation indicates that the site also has a late-nineteenth to twentieth-century historic component. This site is located in the vicinity of a structure that was depicted on an 1904 historic map and includes a stone house foundation, artifact scatter, and garage (garage was burned down between July and November 24, 2009) (see Figure 19). Additional research is needed to ascertain site size, reconstruct the chain-of-title, and determine whether the site possesses the potential to add important information to our understanding of the history of this region (Criterion D). Therefore, it is recommended that this site is avoided. If avoidance is not feasible, it is recommended that Phase II investigations are necessary to evaluate this site under Criterion D to determine its eligibility for listing in the National Register of Historic Places.

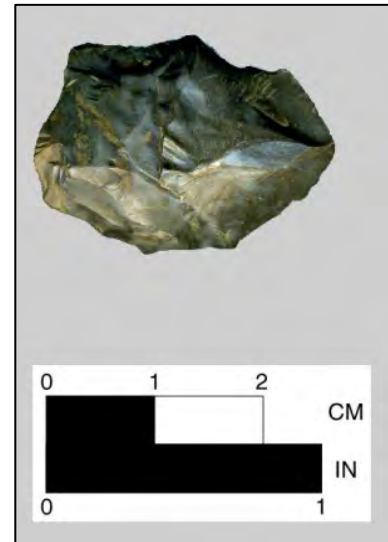
Excavations produced 43 artifacts including one prehistoric artifact and 42 historic artifacts (Table 10). The prehistoric artifact was an indeterminate biface produced from Upper Mercer chert (Photograph 22).

**Photograph 22. Upper Mercer Biface Fragment from Site 36BV131.**

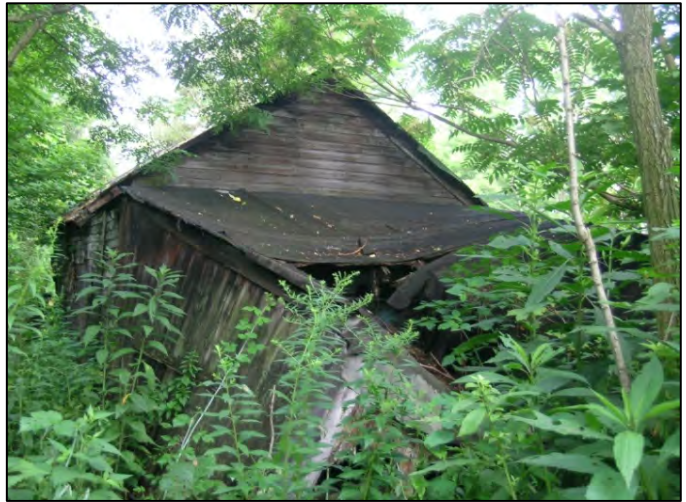
***Photograph 23. Unnamed Garage along Montgomery Dam Road. View to the West.***

This one-story wood-framed garage is located in the central portion of this area (Figure 27). It stands on a wood pier foundation, and its exterior walls are clad with weatherboard siding (Photograph 23). The gable front roof is covered with rolled asphalt and is trimmed with exposed rafter tails. The fenestration consists of two-light, fixed sash windows. However, the glass windowpanes are broken, and chain link fencing now covers the apertures. A shed roof addition had been appended to the rear (east elevation) of the garage, but has collapsed. It features vertical wood siding and rolled-asphalt roofing material. A second addition has been attached to the north elevation. It is clad in plywood and topped with a shed roof. Overall, this garage is severely deteriorated and nearly collapsing.

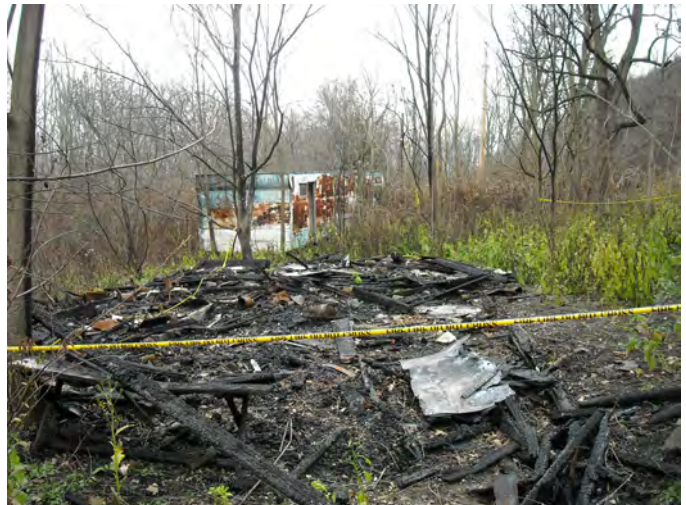
***Photograph 24. Remains of Unnamed Garage after Fire. View to the East.***

Subsequent to the field visit, the garage was destroyed by fire (Photograph 24). A photograph of the burned rubble indicates that one of the foundation walls was set on cinderblocks.

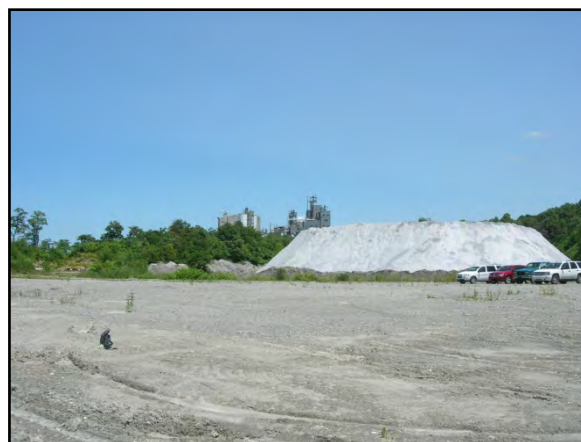
This lot was covered by mixed hardwoods and scrub growth around the periphery, but most of the parcel was part of a gypsum synthetic plant with a large materials stockpile and access roads (Photograph 25). Barge moorings were located along the riverbank. An undeveloped woodlot in the southeastern end of the parcel was a forested wetland area (Photograph 26).

***Photograph 25. Gypsum Stockpile in Montgomery Secondary. View to Northeast.***

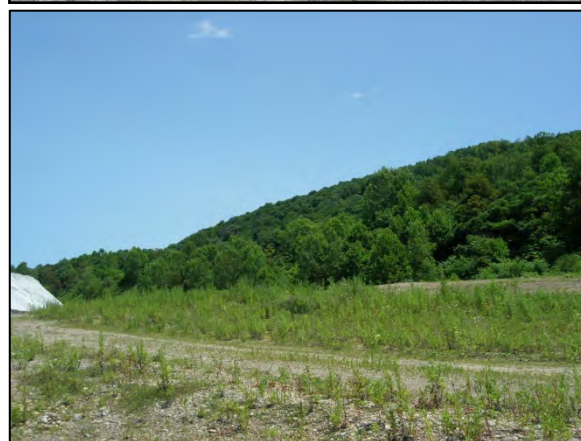
***Photograph 26. Overview of Montgomery Secondary. View to Southeast.***

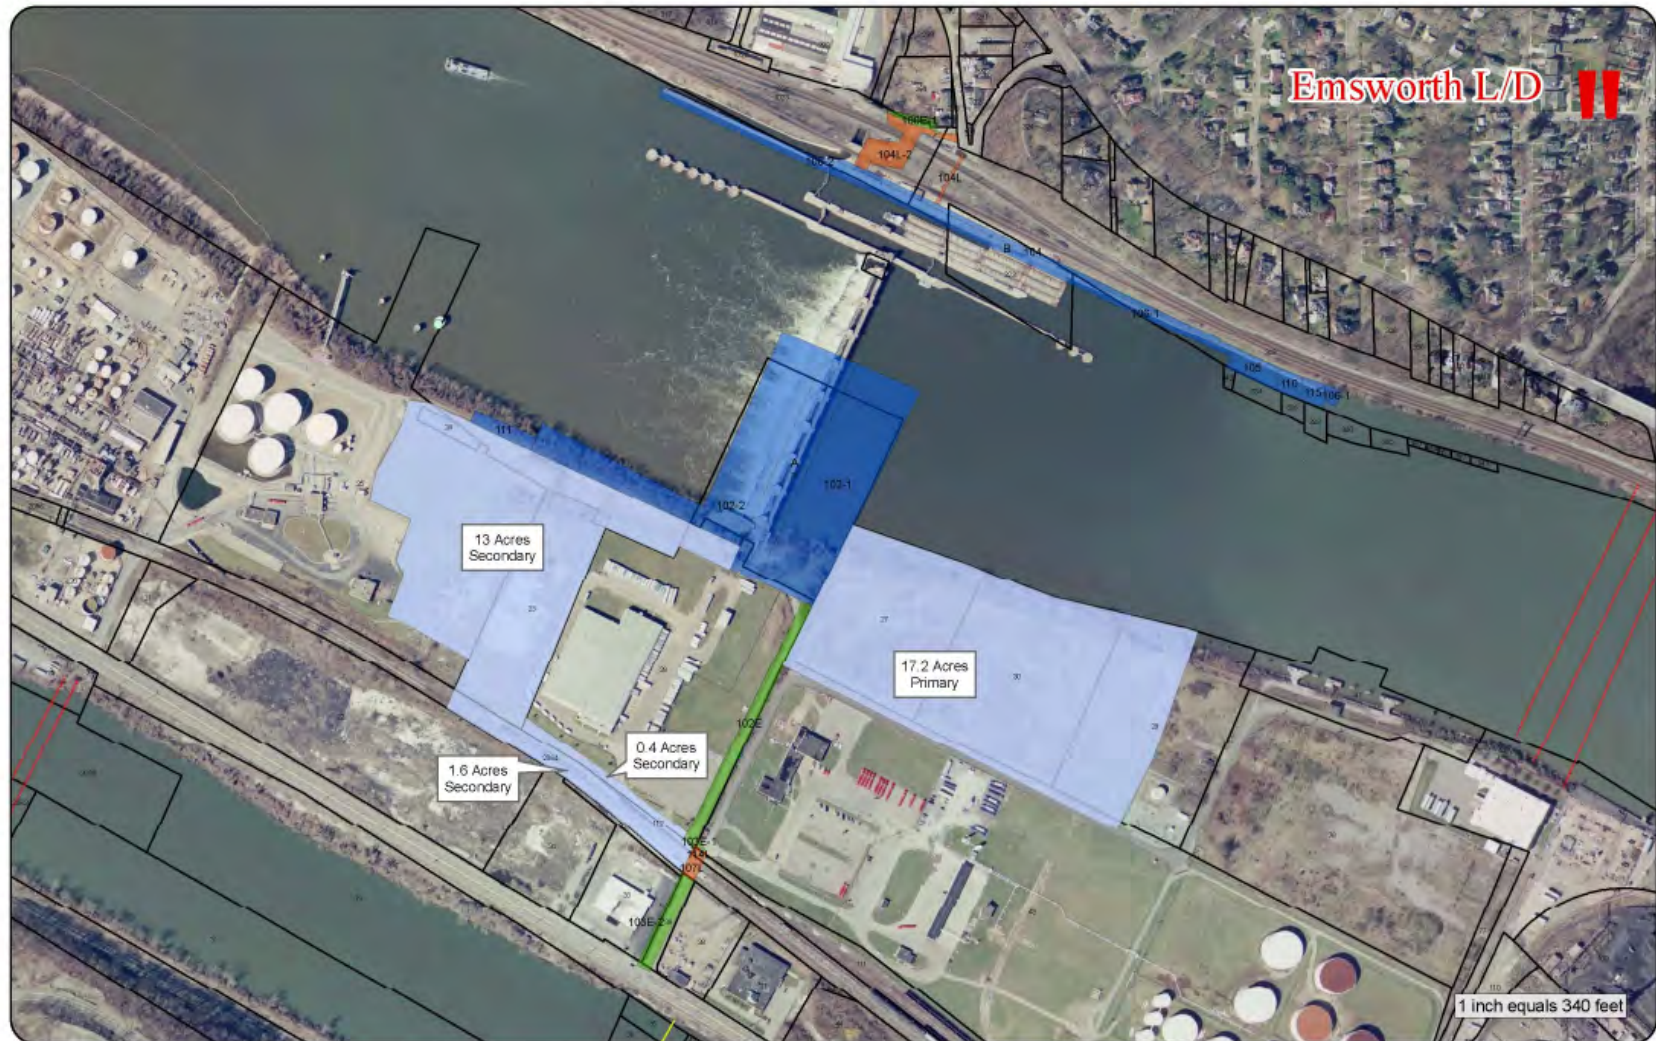
Figure 4. Emsworth Primary and Secondary Work Areas (No cultural resource testing recommended)

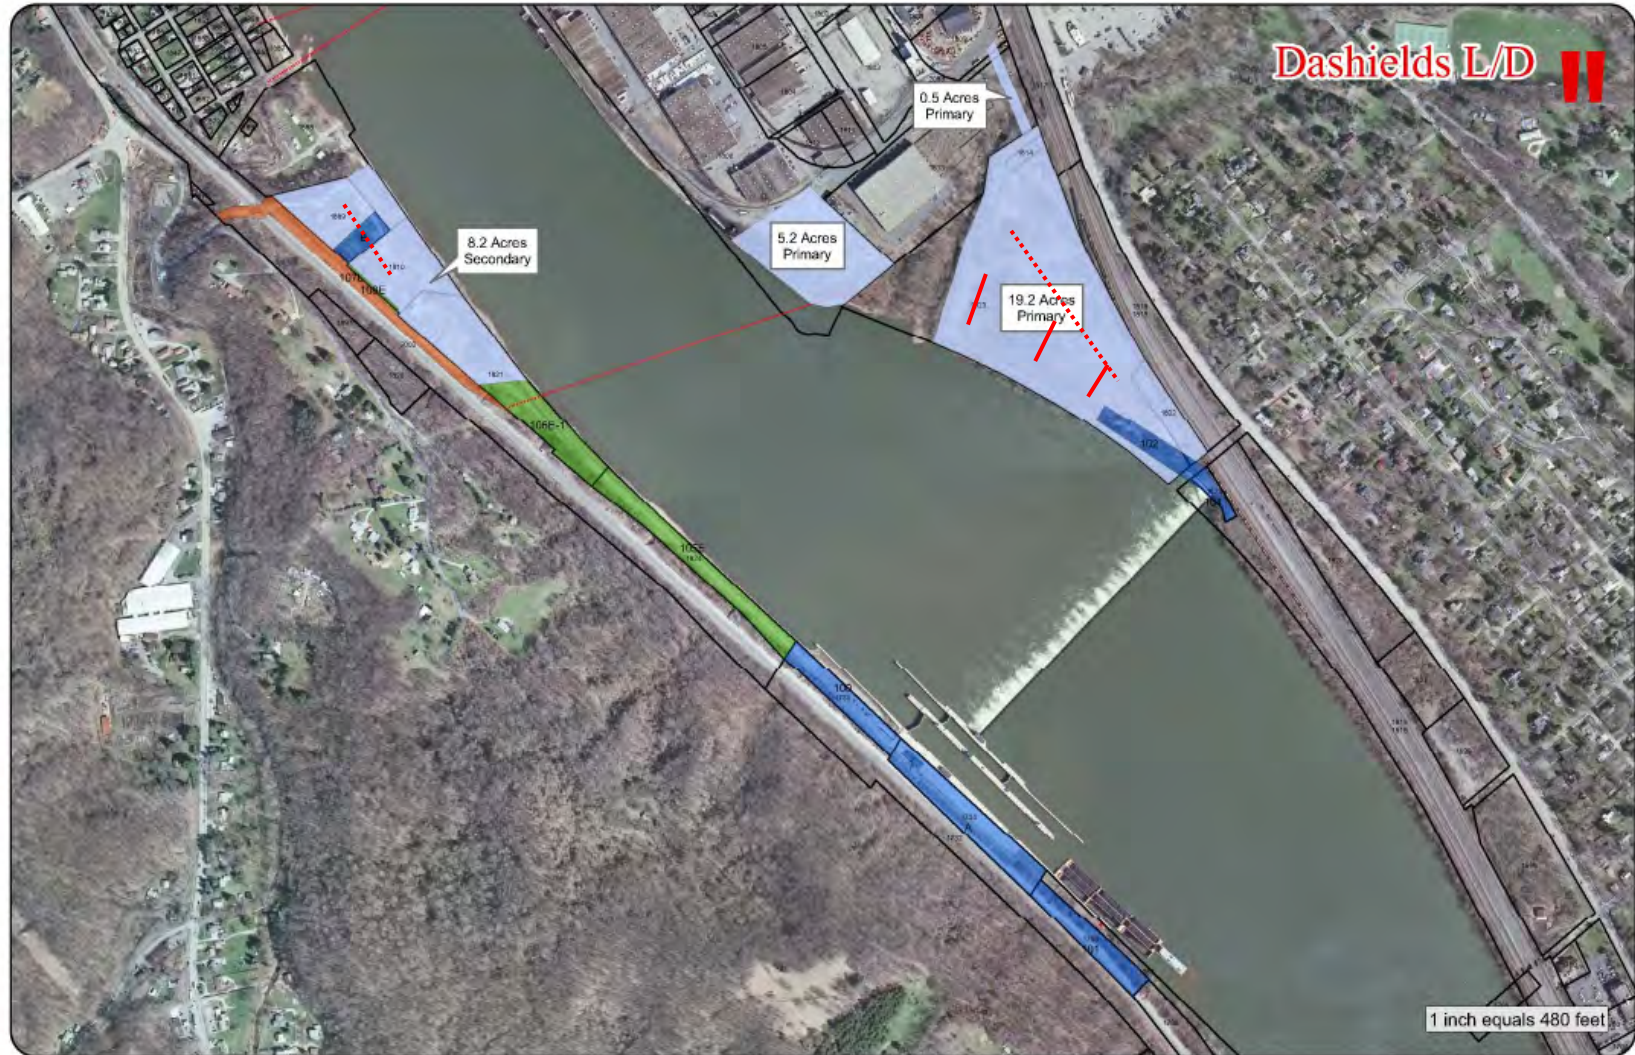
Figure 5. Dashields Primary and Secondary Work Areas (Cultural resource testing shown as solid and dotted red lines)

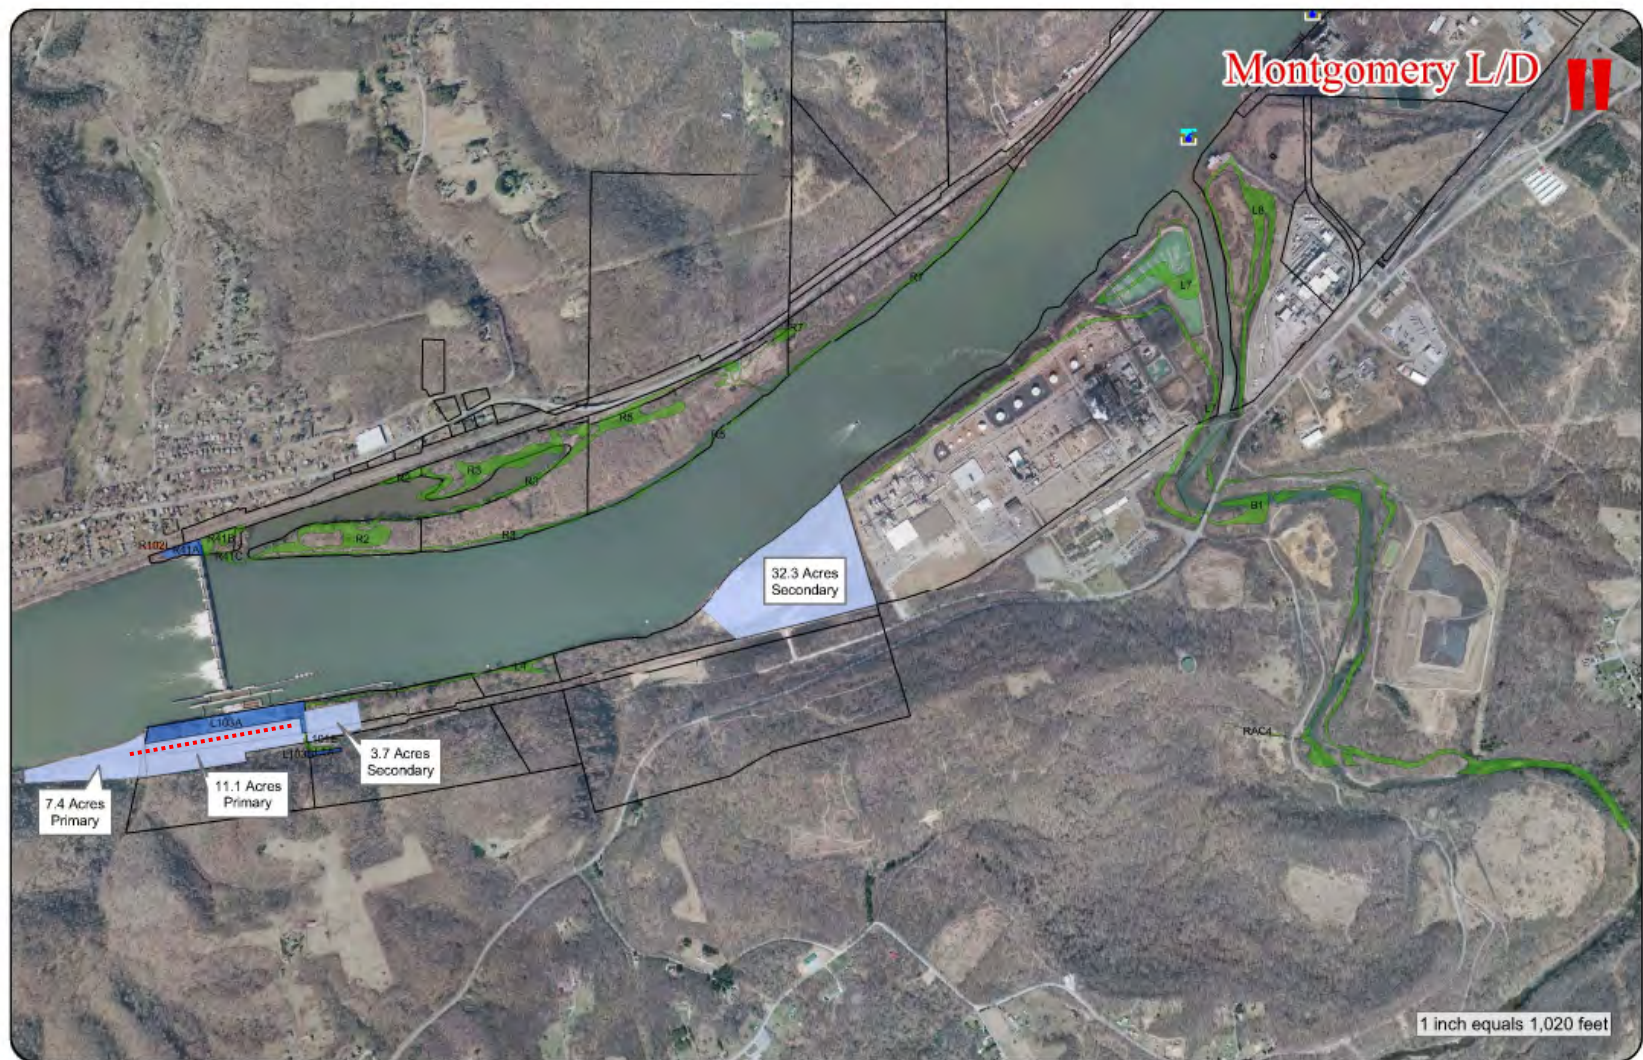
Figure 6. Montgomery Primary and Secondary Work Areas (Cultural resource testing shown as dotted red line, Primary only)

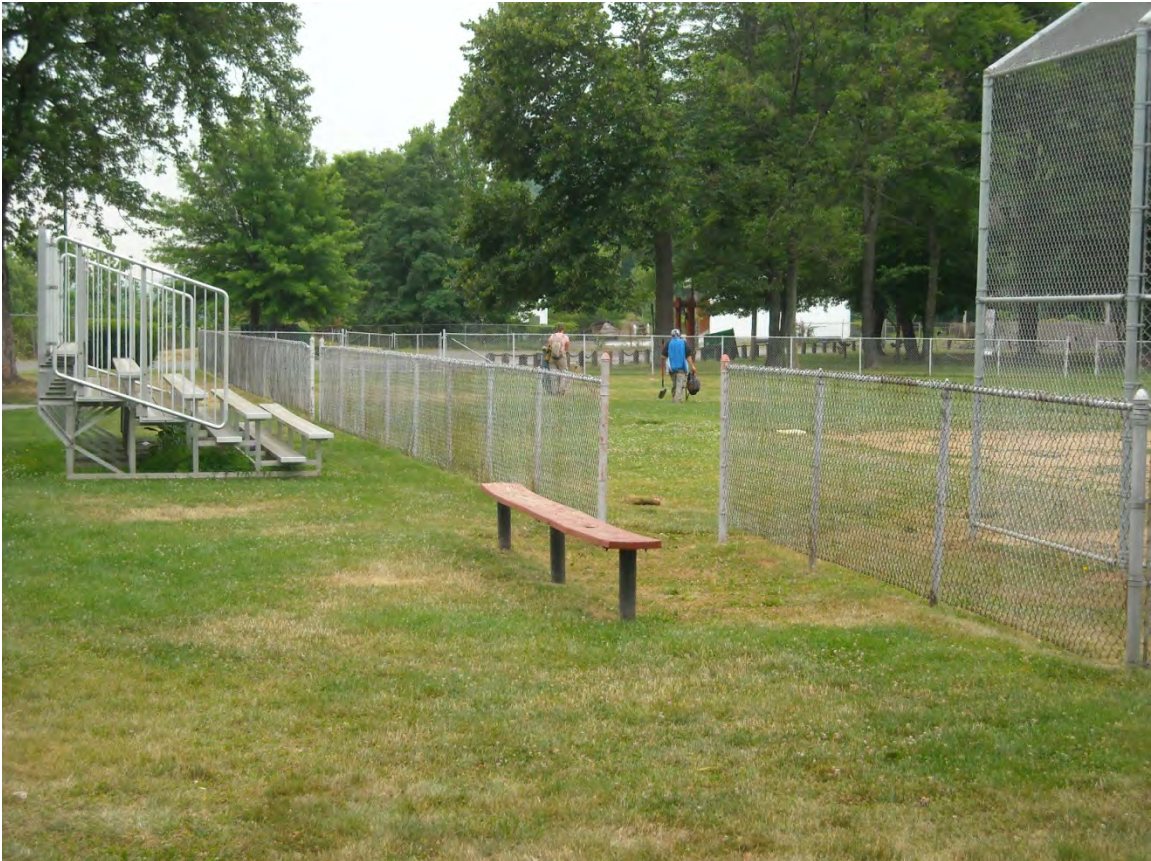
**Photograph 1 Crew digging Shovel Test Pits in baseball diamond**

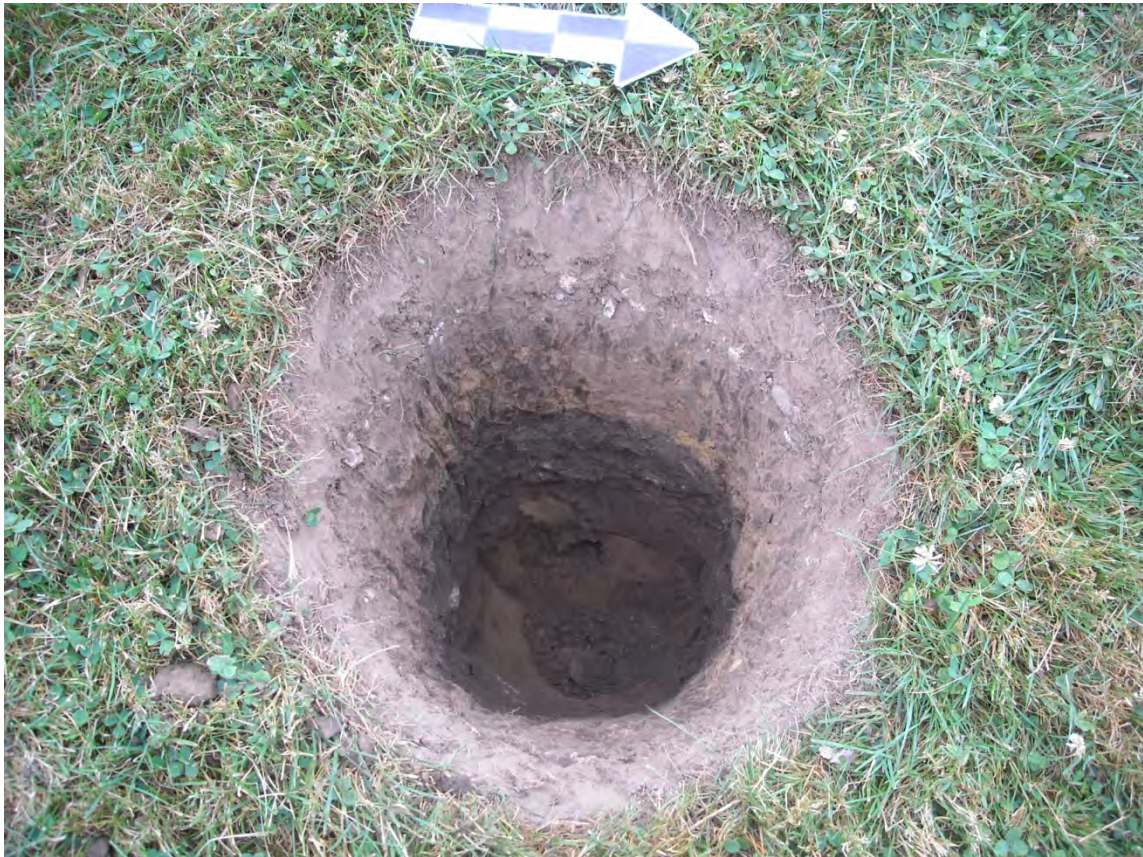
**Photograph 2 Typical Shovel Test Pit**

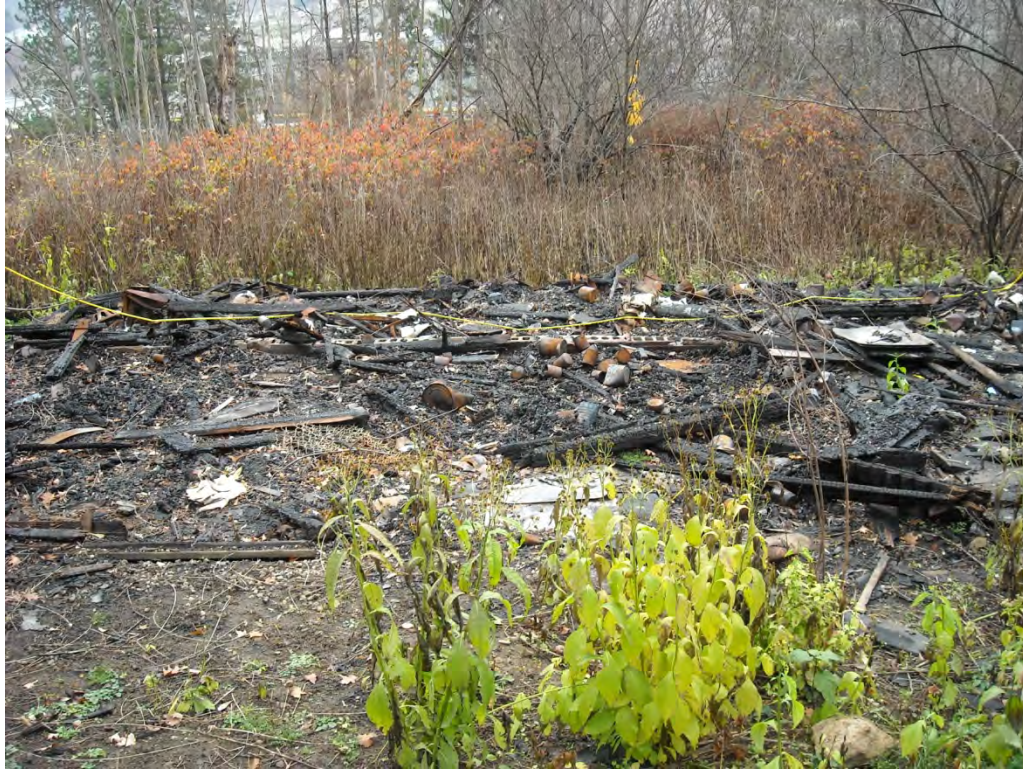
**Photograph 1 Burned Unnamed Garage Area**

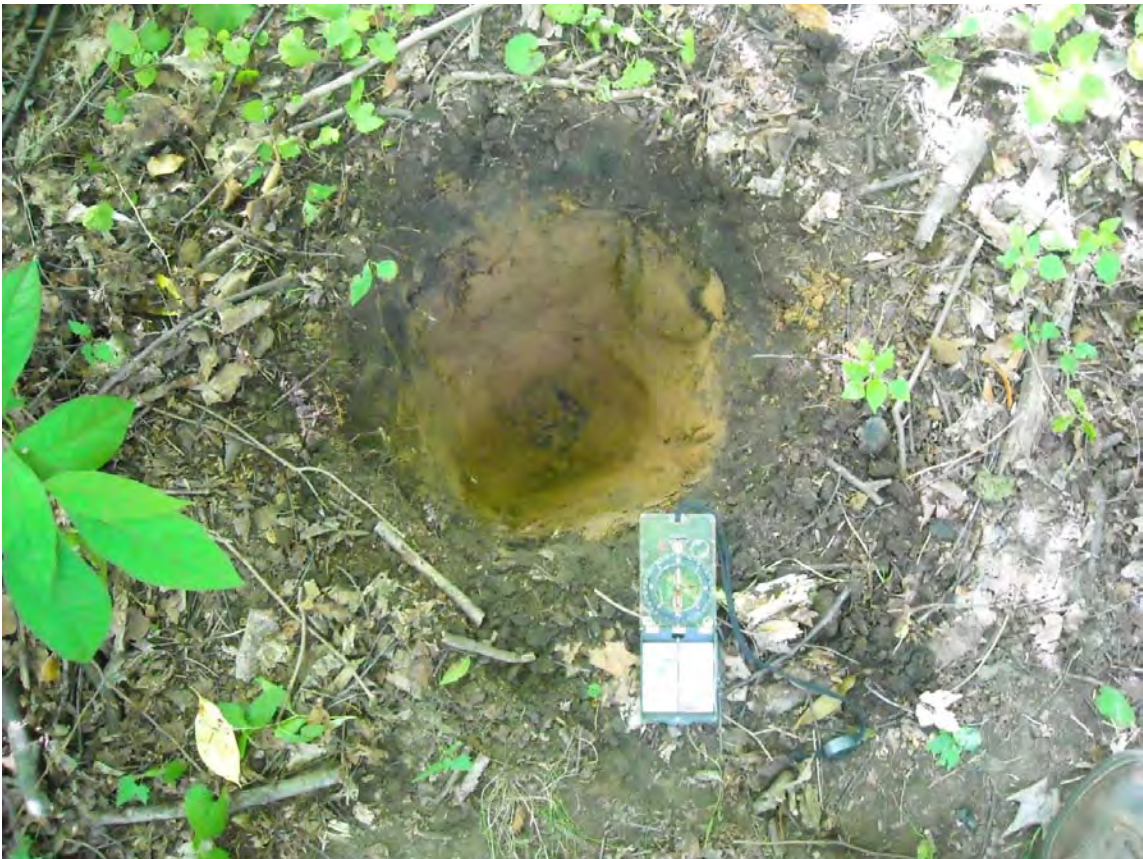
**Photograph 1 Typical Shovel Test Pit (STP 26)**

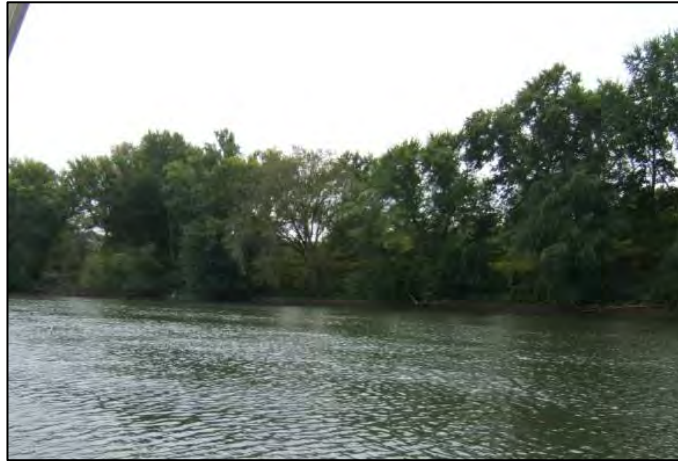
Study Area 5 was viewed by boat on October 7, 2009. There was no visible evidence of remains associated with Davis Island Lock and Dam on the riverbank, but vegetation obscured much of the view (Photograph 1).

***Photograph 1. Overview of SA 5.  
View Southeast.***

Remnants of this NRHP-listed former Davis Island Lock and Dam may be present in Study Area 5. Therefore, this area is considered to have high potential for intact archaeological resources associated with this lock and dam in both the river channel and the riverbank. A ground reconnaissance and a review of interpreted side-scan sonar images are recommended to identify the location of any intact remains associated with the NRHP-listed Davis Island Lock and Dam site that fall within the SA 5 APE. Subsurface testing is recommended at the tie-in location if intact soils are present.

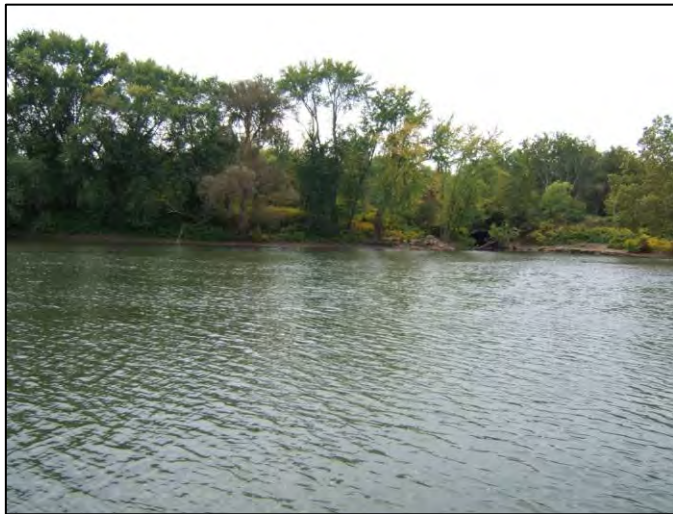
Study Area 7 was viewed by boat on October 7, 2009. There was no visible evidence of any archaeological remains along the shoreline but vegetation obscured much of the view (Photograph 2).

***Photograph 2. Overview of SA 7.  
View Southeast.***

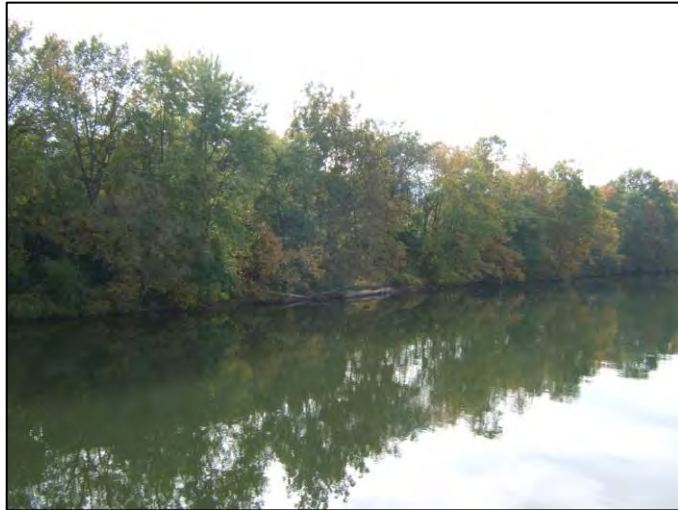
Study Area 10 was viewed by boat on October 7, 2009. There was no visible evidence of any archaeological remains or industrial dumps along the shoreline but vegetation obscured much of the view (Photograph 3).

***Photograph 3. Overview of SA 10.  
View Southeast.***

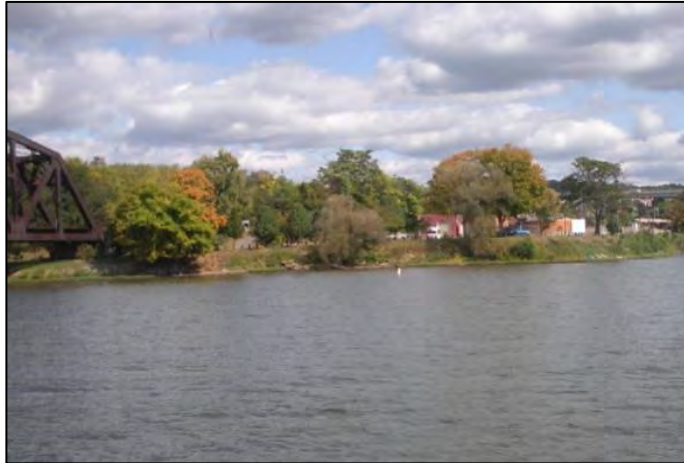
SA 11 was viewed by boat on October 6, 2009. The entire APE is submerged (Photograph 4).

***Photograph 4. Overview of SA  
11 (in Ohio River). View  
Northeast.***

The APE for Study Area 11 is located entirely within the Ohio River. There are no known recorded archaeological or architectural resources, or mapped historic-era resources, associated with SA 11. No additional archaeological investigations are recommended except to review interpreted side-scan sonar images to confirm that there are no submerged resources over 50 years of age within this riverine APE.

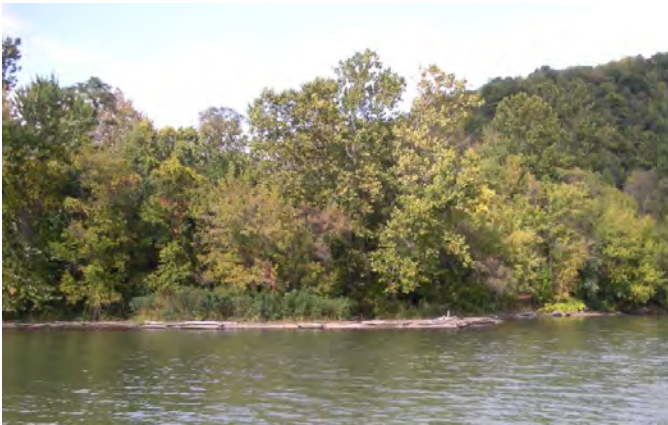
SA 13 was viewed by boat on October 6, 2009. There was no visible evidence of any archaeological remains along the shoreline. Vegetation and floating logs along the

***Photograph 5. Overview of Shoreline along SA 13. View Northeast.***

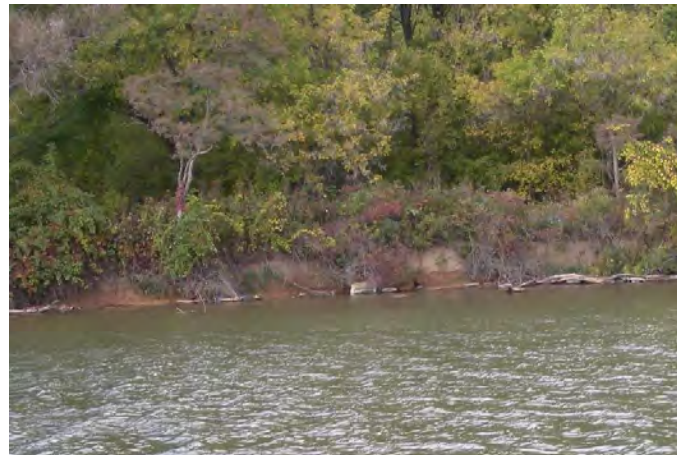
shoreline obscured much of the view (Photograph 5). Part of the shoreline was also eroded (Photograph 6).

***Photograph 6. Eroded Shoreline along SA 13. View North.***

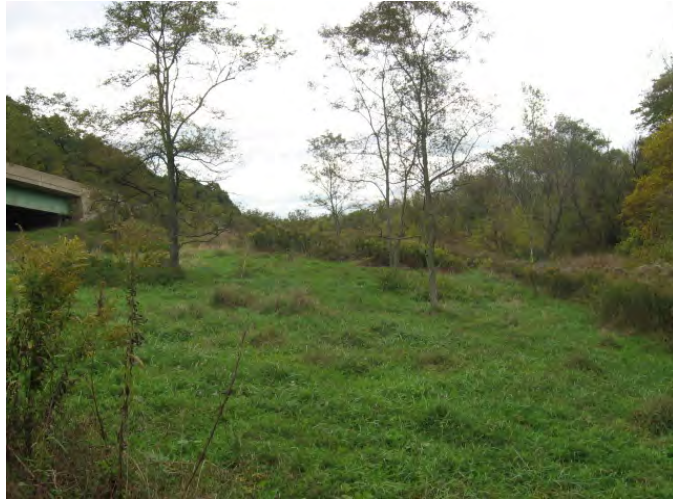
addition, concrete debris from the realignment of a road just north of the APE was buried on the northern part of SA 14 (USACE nd) (Photograph 7). As a result of past activities, the east and south sides of the APE are irregular and hummocky, part of the northern end is disturbed, and wetlands are situated at its western extent and north of the inlet (USACE nd).

***Photograph 7. Overview of North Side of SA 14. View East. (Photograph Courtesy of Aerostar Environmental Services, Inc.)***

The upland shrub and herbaceous plant habitat located along an access road on the north side of the APE was heavily disturbed and hummocky with localized areas that appeared to be undisturbed (see Photograph 7). Based on background research and pedestrian reconnaissance, these undisturbed areas had a high potential for intact soils and archaeological remains.
